DELAWARE VALLEY WORKS FACILITY  
INTERIM REMEDIAL MEASURE COMPLETION REPORT  
UPPER SLUICeway CLEANOUT  
CLAYMONT, DELAWARE

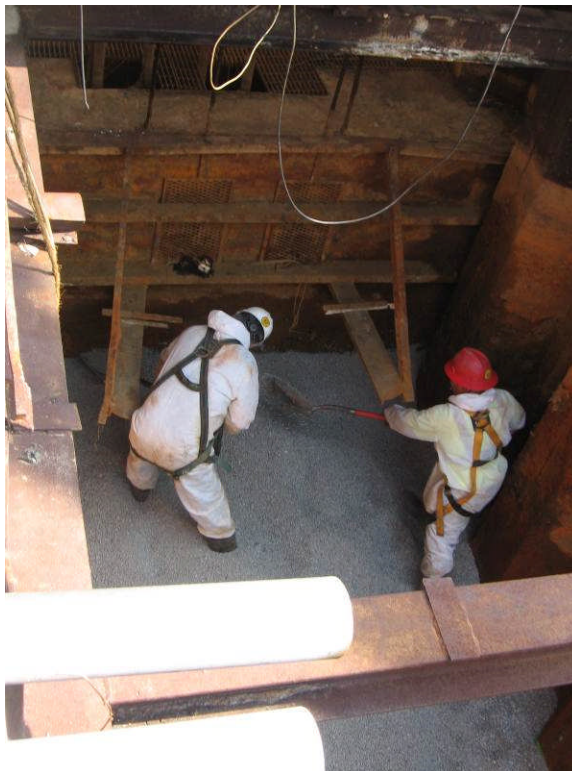
View of the minimum 6-inch thick AquaBlok® layer being placed upstream of the weir.

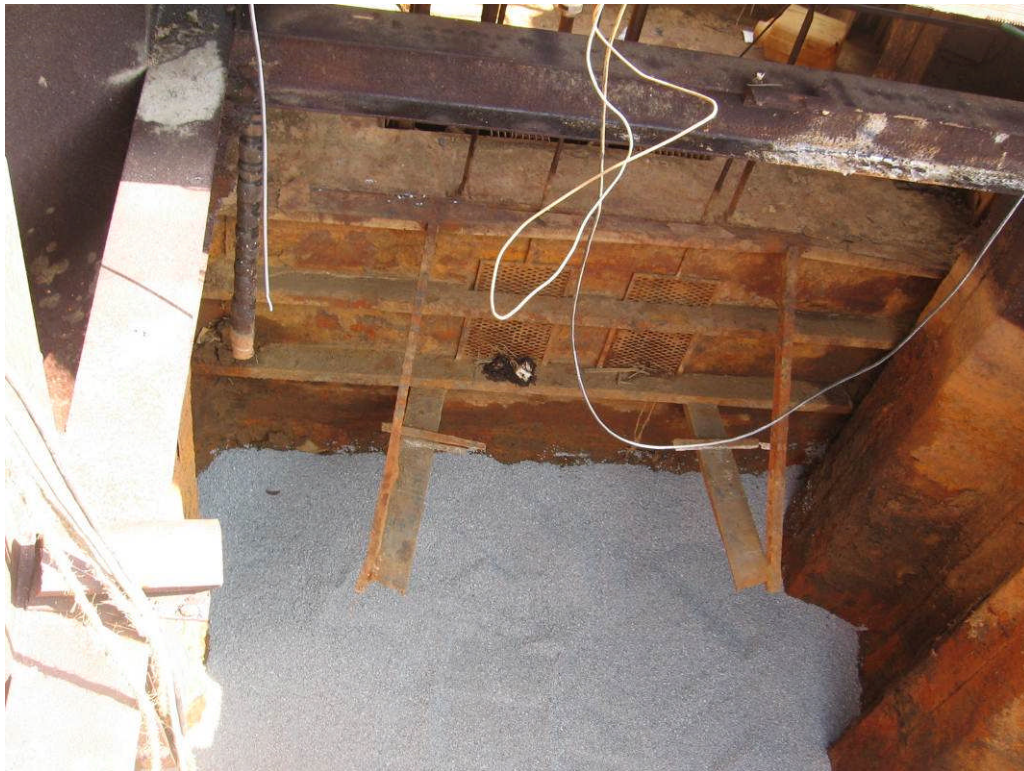
View of the minimum 6-inch thick AquaBlok® layer in the upper sluiceway upstream of the weir.

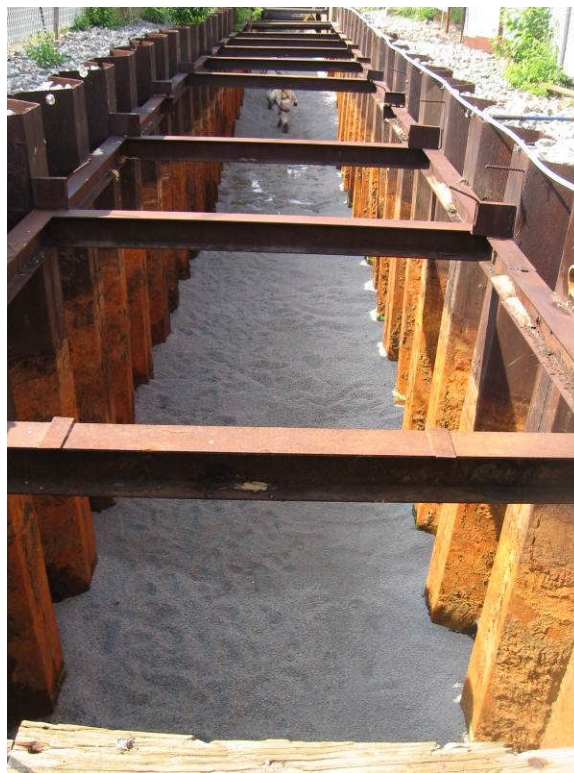
View of the minimum 6-inch thick AquaBlok® layer in the upper sluiceway.
